# Concrete Lifting

### CASE HISTORY

Royal Saint Georges  
Fords Colony Williamsburg, VA

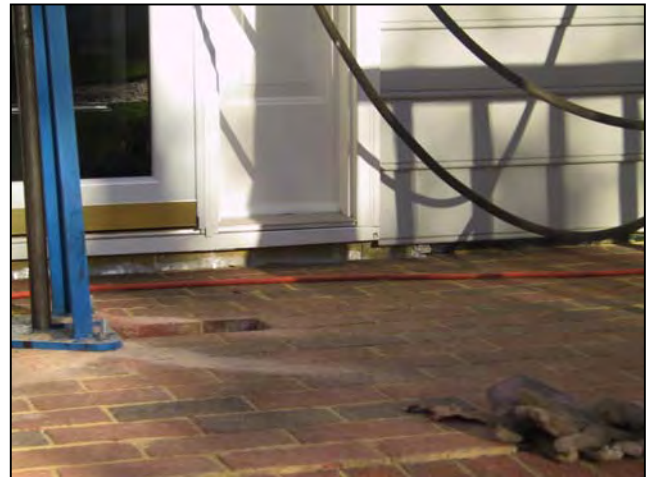
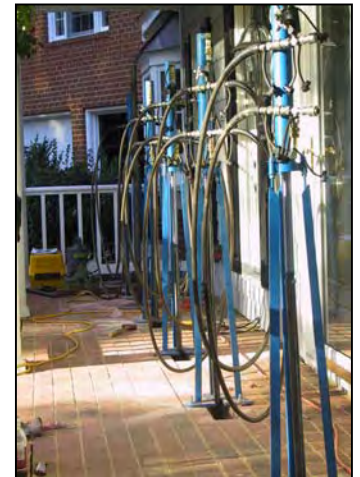
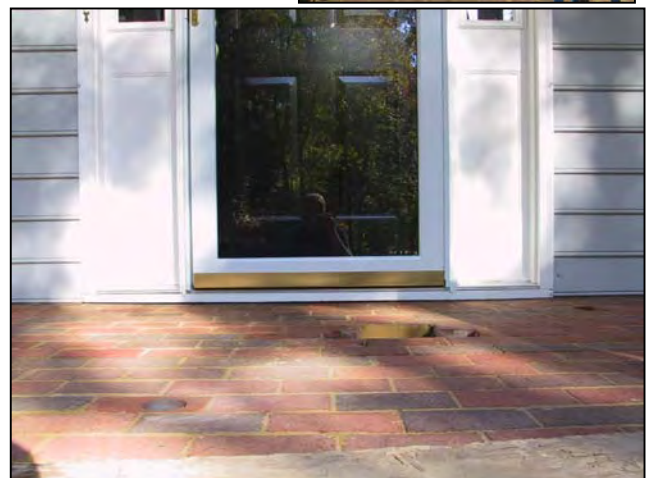
A residential custom home front porch slab overlaid brick paving system had settlement of up to 1 ½ “ due to the compression of sub-soils. Also, the interior crawl space and exterior porch foundation wall had settlement and distress.

The foundation was stabilized with Magnum 3” steel piers with heavy-duty Magnum angle brackets. Three total piers were required.

The installation of Magnum slab piers 5’ on center were utilized to transfer slab loads to proper subsoils.

**Slab Jacking** - After the piers were in place, 81 cubic feet of cementitious grout was injected into the void. Grout was injected between the slab and sub soils to consolidate the soil, fill the voids and support the slab/paver system. A total of five working days were required to make repairs.

The paving system settlement was corrected up to 1 ½” of lift, which returned the paving system to its original elevation. The above methods of repairs were less destructive and saved thousands of dollars over typical removal and replacement methods. Upon completion of this project, the owners contracted with Advanced Builders to complete masonry repairs and restoration.
