# CASE HISTORY

Carlin Ranch  
Rock River, Wyoming

## 27 - Push Piers Driven to a depth of 33' below the basement

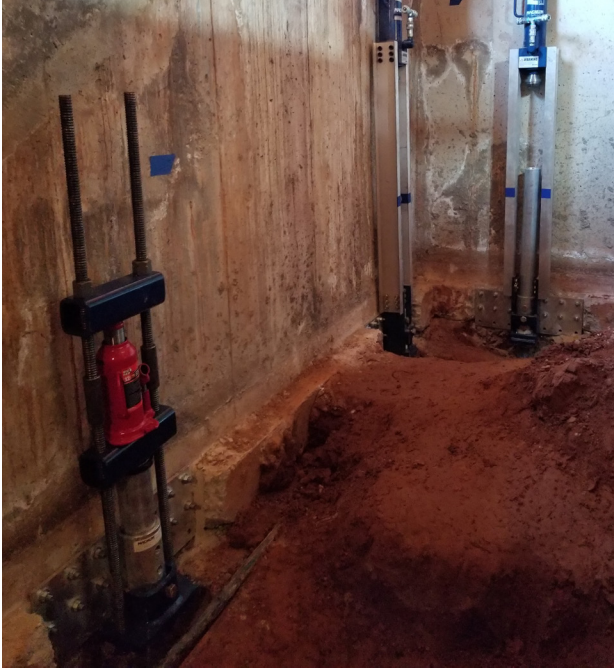
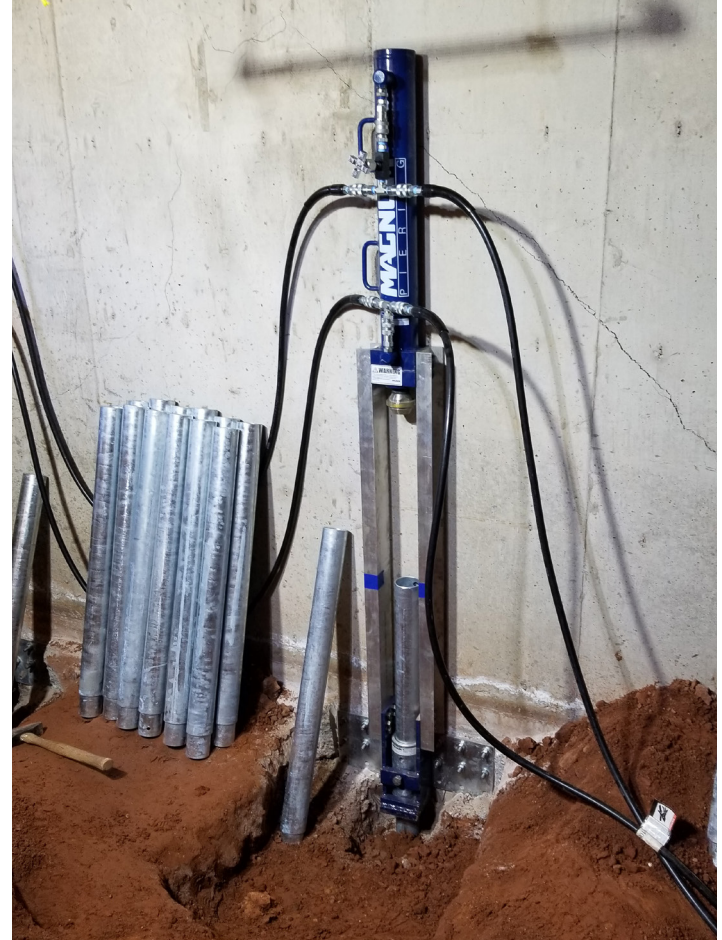
A cattle ranch located in Rock River, WY that was built in 1985 and has been settling since. This has developed into issues with opening doors and windows as well as various settling throughout the structure. Underground exploration revealed streams that caused issues with the soil beneath the home.
